## 41 Year-Old Male Dies after Being Struck in the Head with an Auger

**Incident Number:** 02KY127  
**Date of Incident:** October 23, 2002  
**Report Release Date:** June 17, 2003

## **Kentucky Fatality Assessment & Control Evaluation (FACE) Program**

**Incident: 02KY127**

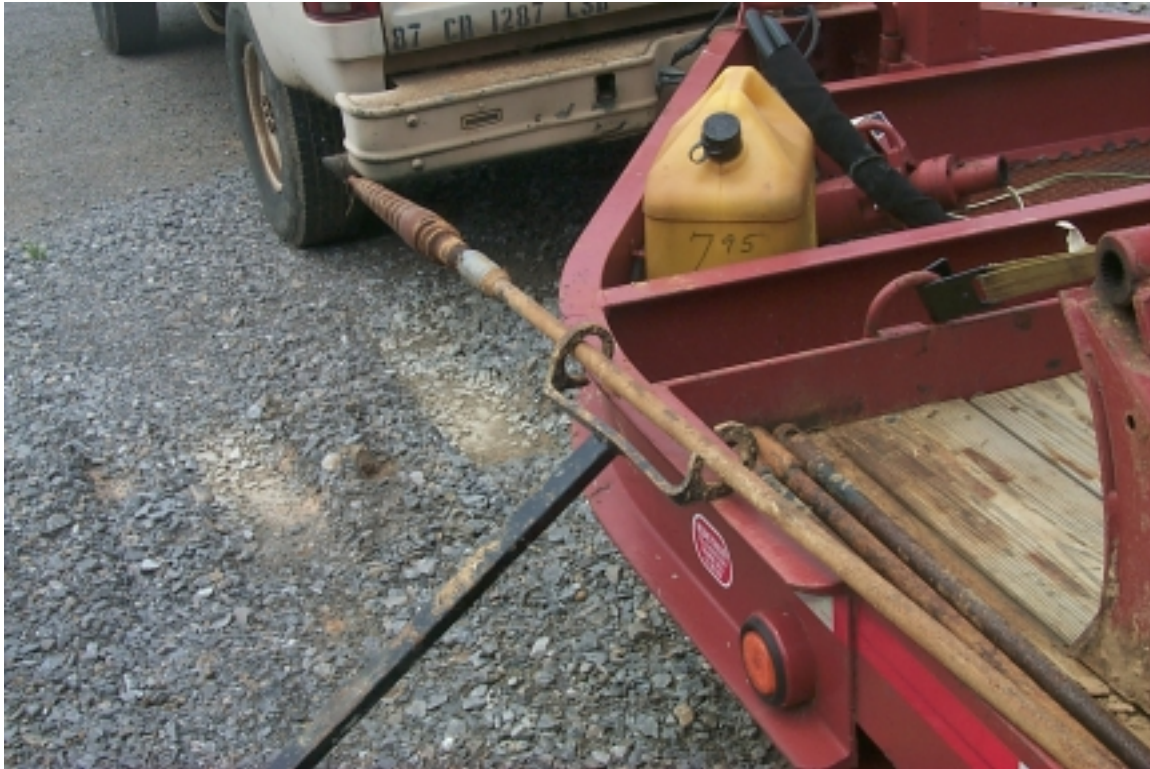
There are four components to the auger: the power train, the rod, the handle and the bit. The bit is attached to the end of the rod, which is guided on the side by the handle. The handle has two open loops that are open on opposite sides of the loop. These loops fit over the rod. The power train makes the rod and bit rotate to move forward or backward. The handle on the rod allows the operator to guide the bit where it needs to bore. The handle should not touch the bit, only the rod. According to safe operating procedures, when the bit direction is reversed, the handle needs to be removed. This prevents the bit from becoming entangled in the handle. Training should be reinforced on a regular basis on correct use of augers. Had the handle been removed prior to reversing direction, this incident may have been prevented.

Auger bit with handle in proper location on rod to guide bit forward.

When an auger is being operated forward, it can be guided by a handle. When the bit direction is reversed, the handle should be removed. This keeps the bit from becoming entangled in the handle. The decedent had safely operated the auger hundreds of times before the incident occurred. It is unknown why he did not remove the handle in this particular instance. Perhaps manufacturers could research different handle designs and attachment mechanisms to allow the handle to stay attached safely while the bit is moving in the reverse direction. Another option would be to have the bit un-operational in the reverse direction when the handle is still attached.

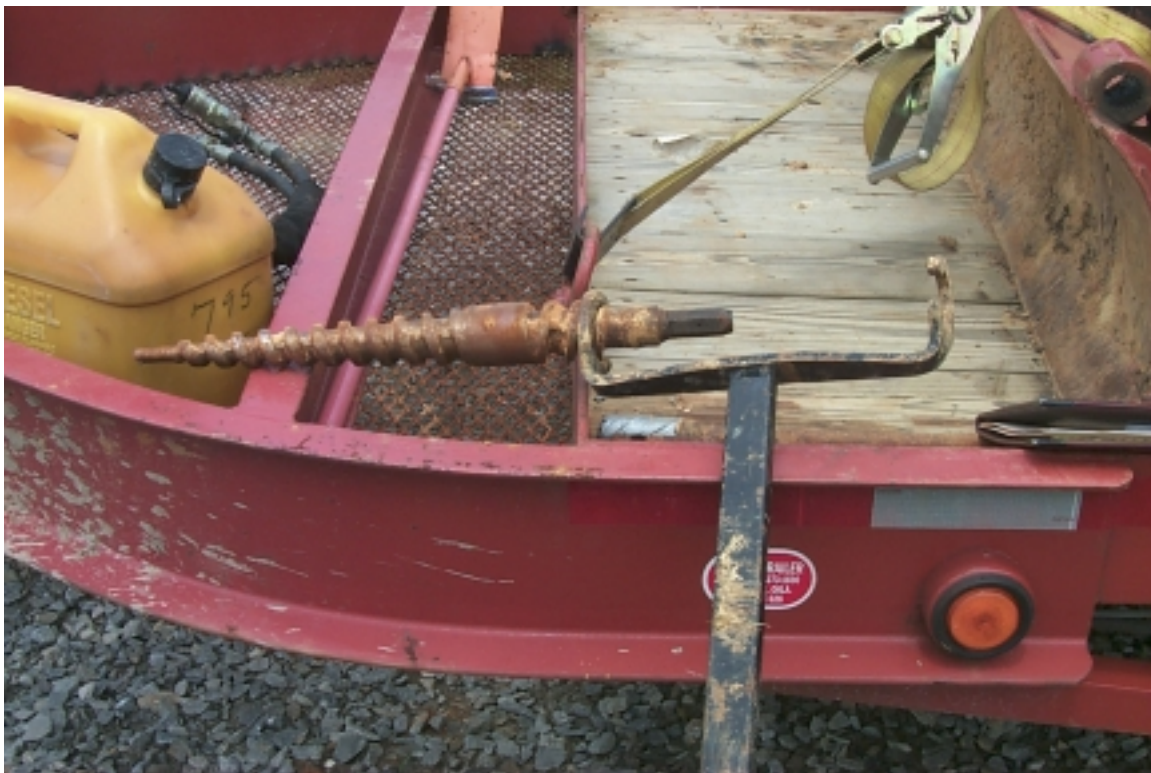
Auger bit threaded into handle as it would have done at time of incident.

Note: As of the writing of this report, the handle design has been redesigned by the manufacturer to break away if the bit and rod become uncontrollable. The handles are being replaced free of charge to customers.
